**INVESTIGATION OF  
IGNITER COMPOSITION FIRE  
BAY 9 BUILDING G-11  
LONESTAR ARMY AMMUNITION PLANT  
15 MAY 1991**

**ROBERT A. LOYD**

**U.S. ARMY ARMAMENT  
MUNITIONS AND CHEMICAL COMMAND**

**25th DEPARTMENT OF DEFENSE  
EXPLOSIVES SAFETY SEMINAR  
18-20 AUGUST 1992**

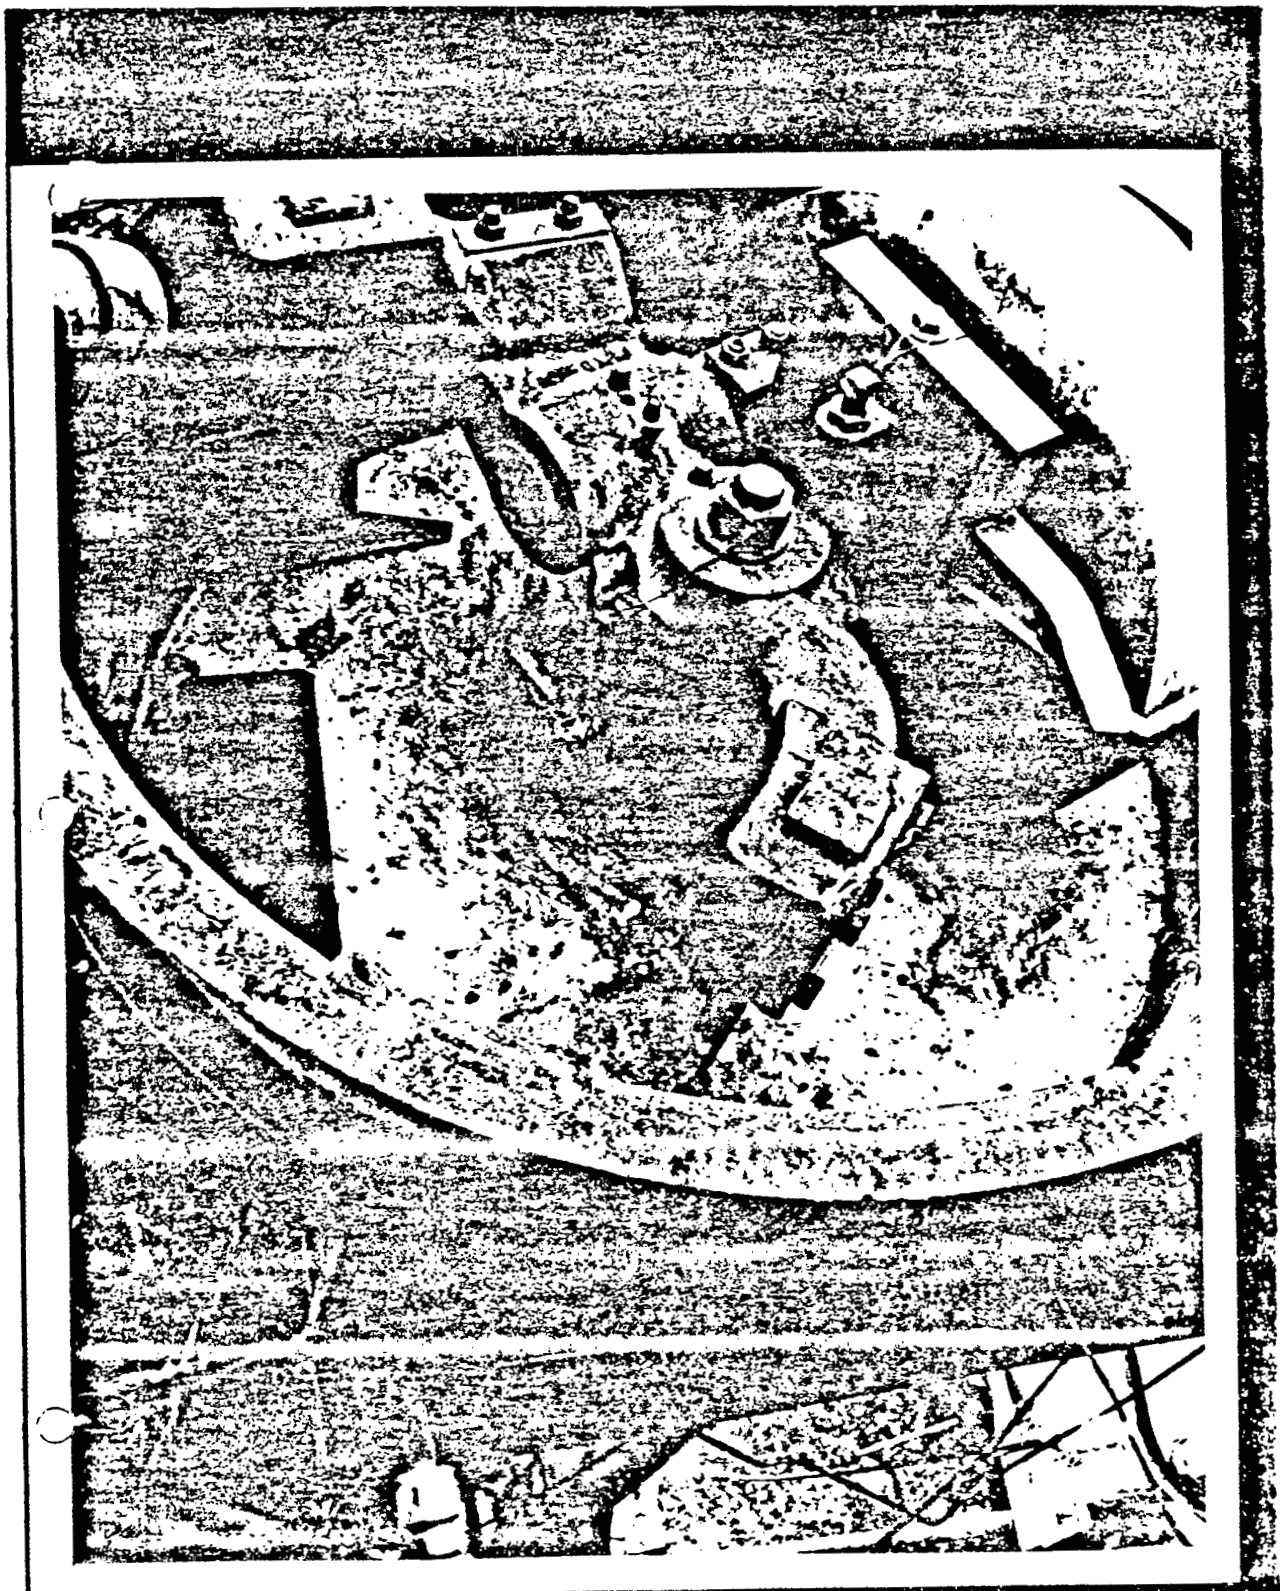
a. The mixer involved in the incident has been in service at Lone Star AAP since July 1951. It shows signs of wearing out as a result of extended service and an undetermined number of previous incidents.

b. Worn areas were discovered in the hub area of the axle assembly in the mixing bowl. A sharpened edge and an indentation in the ring were discernible. Furthermore, extensive pitting of

the ring in the hub assembly was evident. The millwrights indicated they had not seen this pitting when they repaired the bowl after the September incident. The millwrights attributed this pitting to water buildup in that area. These hub anomalies could possibly cause a wobbling of the wheel and plow assembly.

Mix muller. Dump door/opening is at 9:00 position.

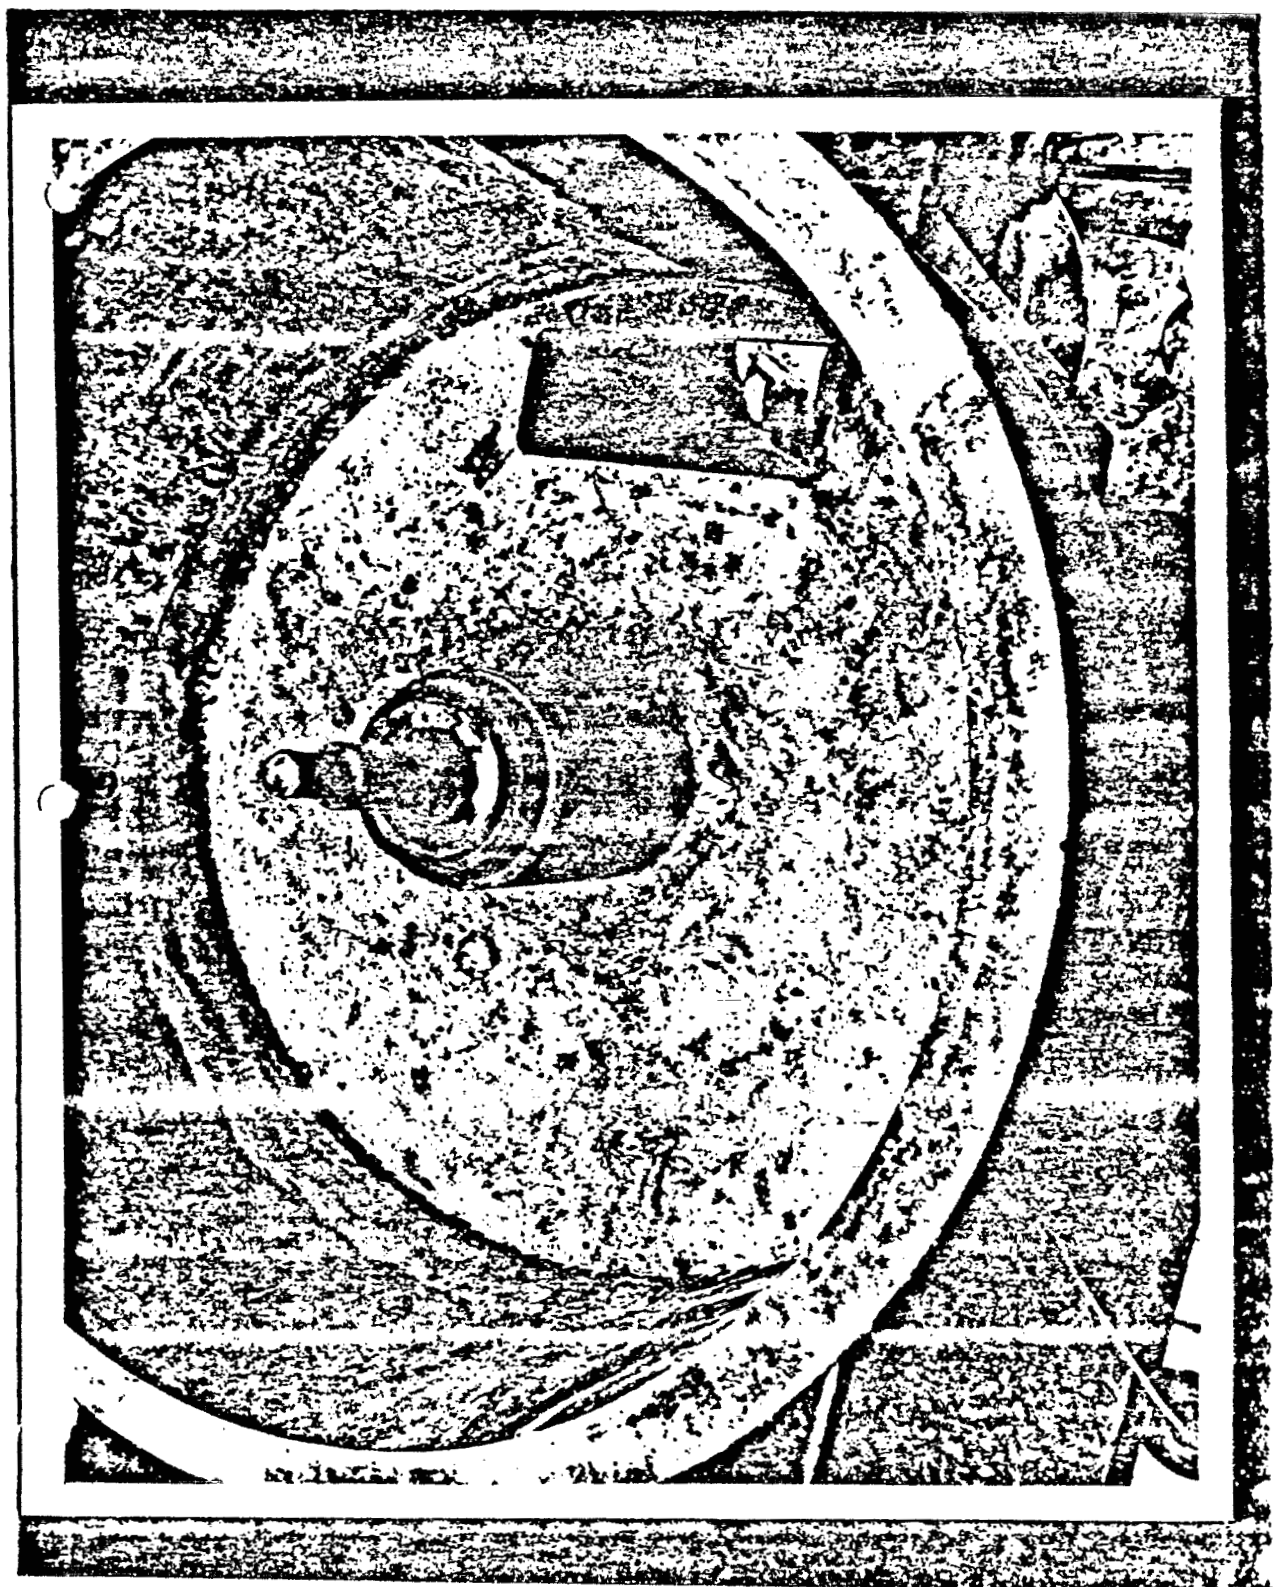
a. The interior of the mixing bowl showed the presence of concentric circular grooves on the bottom of the bowl. The depth of the grooves was measured at four random locations. The depth varied from 0.007 inches to 0.015 inches. The maintenance personnel indicated that the grooves were there following the September 1990 incident. The grooves were hand-polished with emery cloth to attempt to smooth them down. It is not known if the depth of the grooves increased between September 1990 and May 1991.

b. There were marks on the side of the mixing bowl. The marks appeared from approximately the 7 o'clock to the 9 o'clock position. Eleven distinct sets of marks were visible and all had the appearance of being caused by metal to metal contact. The marks were vertically linear in arrangement. They occurred from approximately 4-8 inches above the floor of the bowl.

Mix muller with wheel assembly removed.

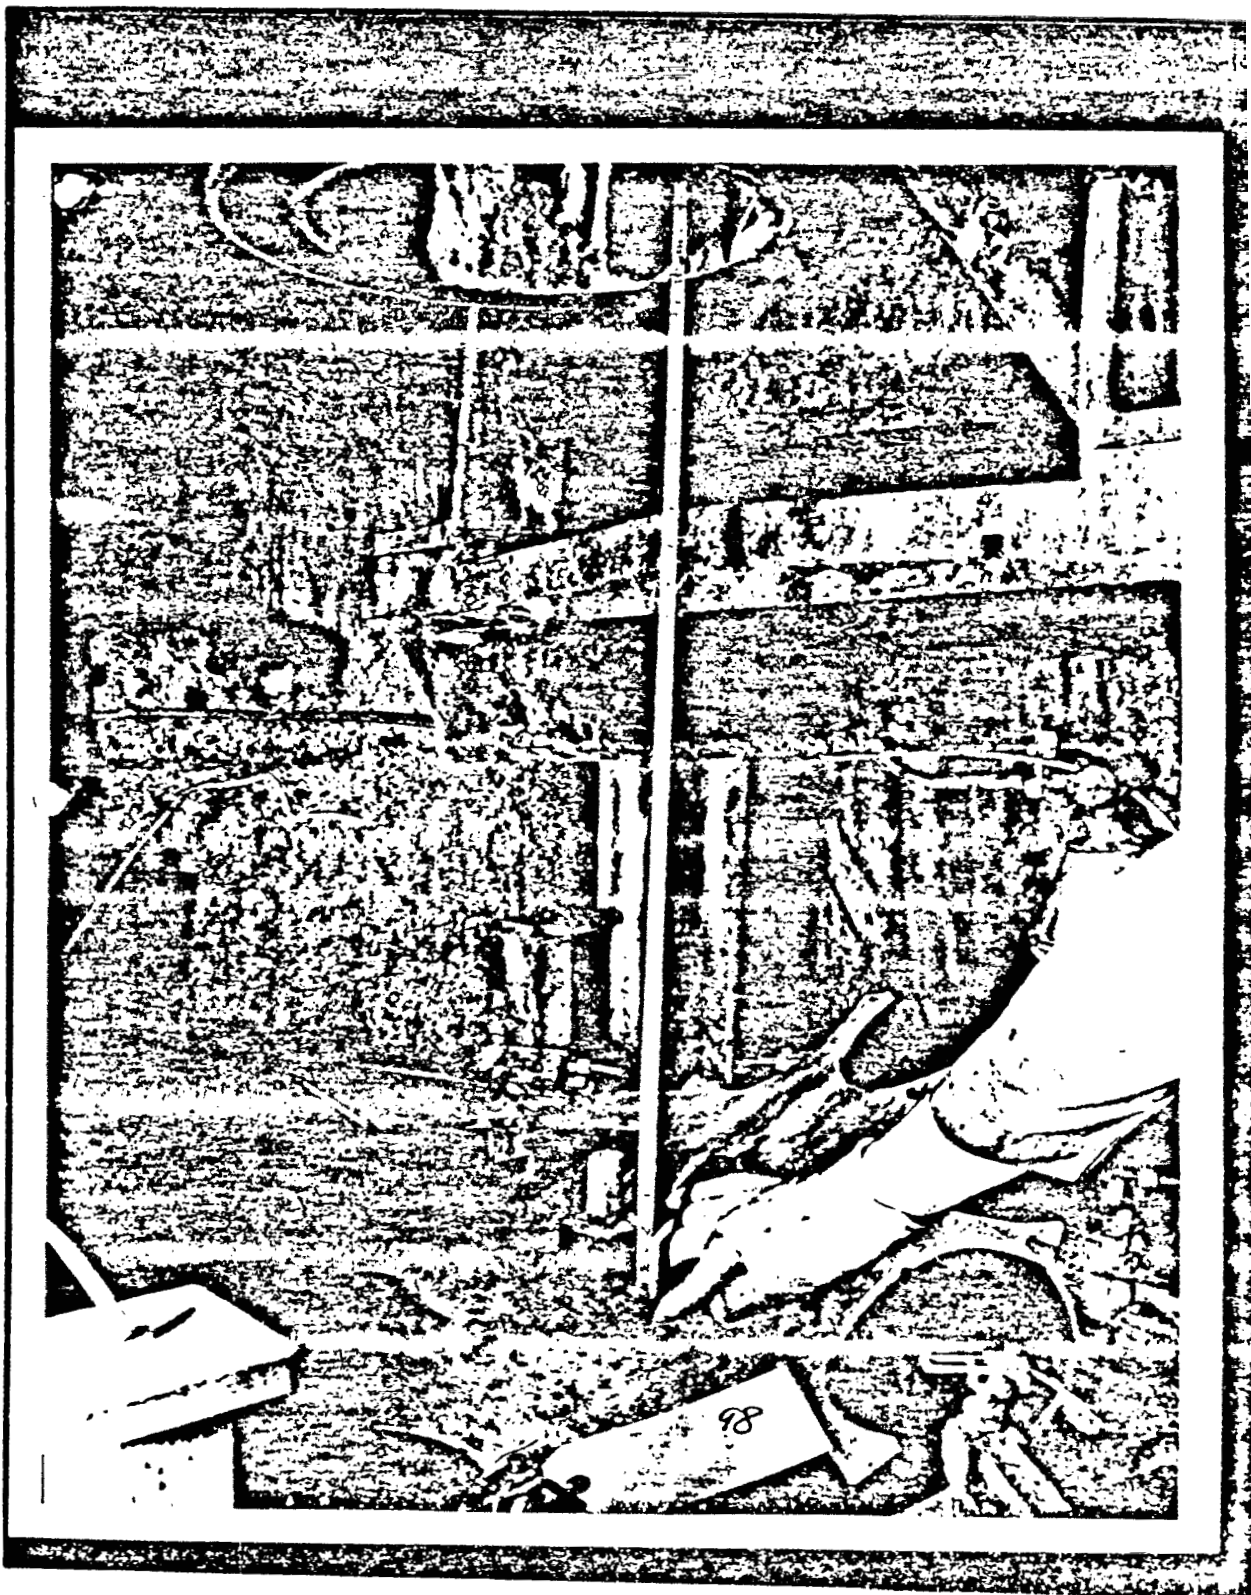
Shows the distance the igniter mix had to drop from the mixer to the dial assembly. (approximately 3.5 ft)

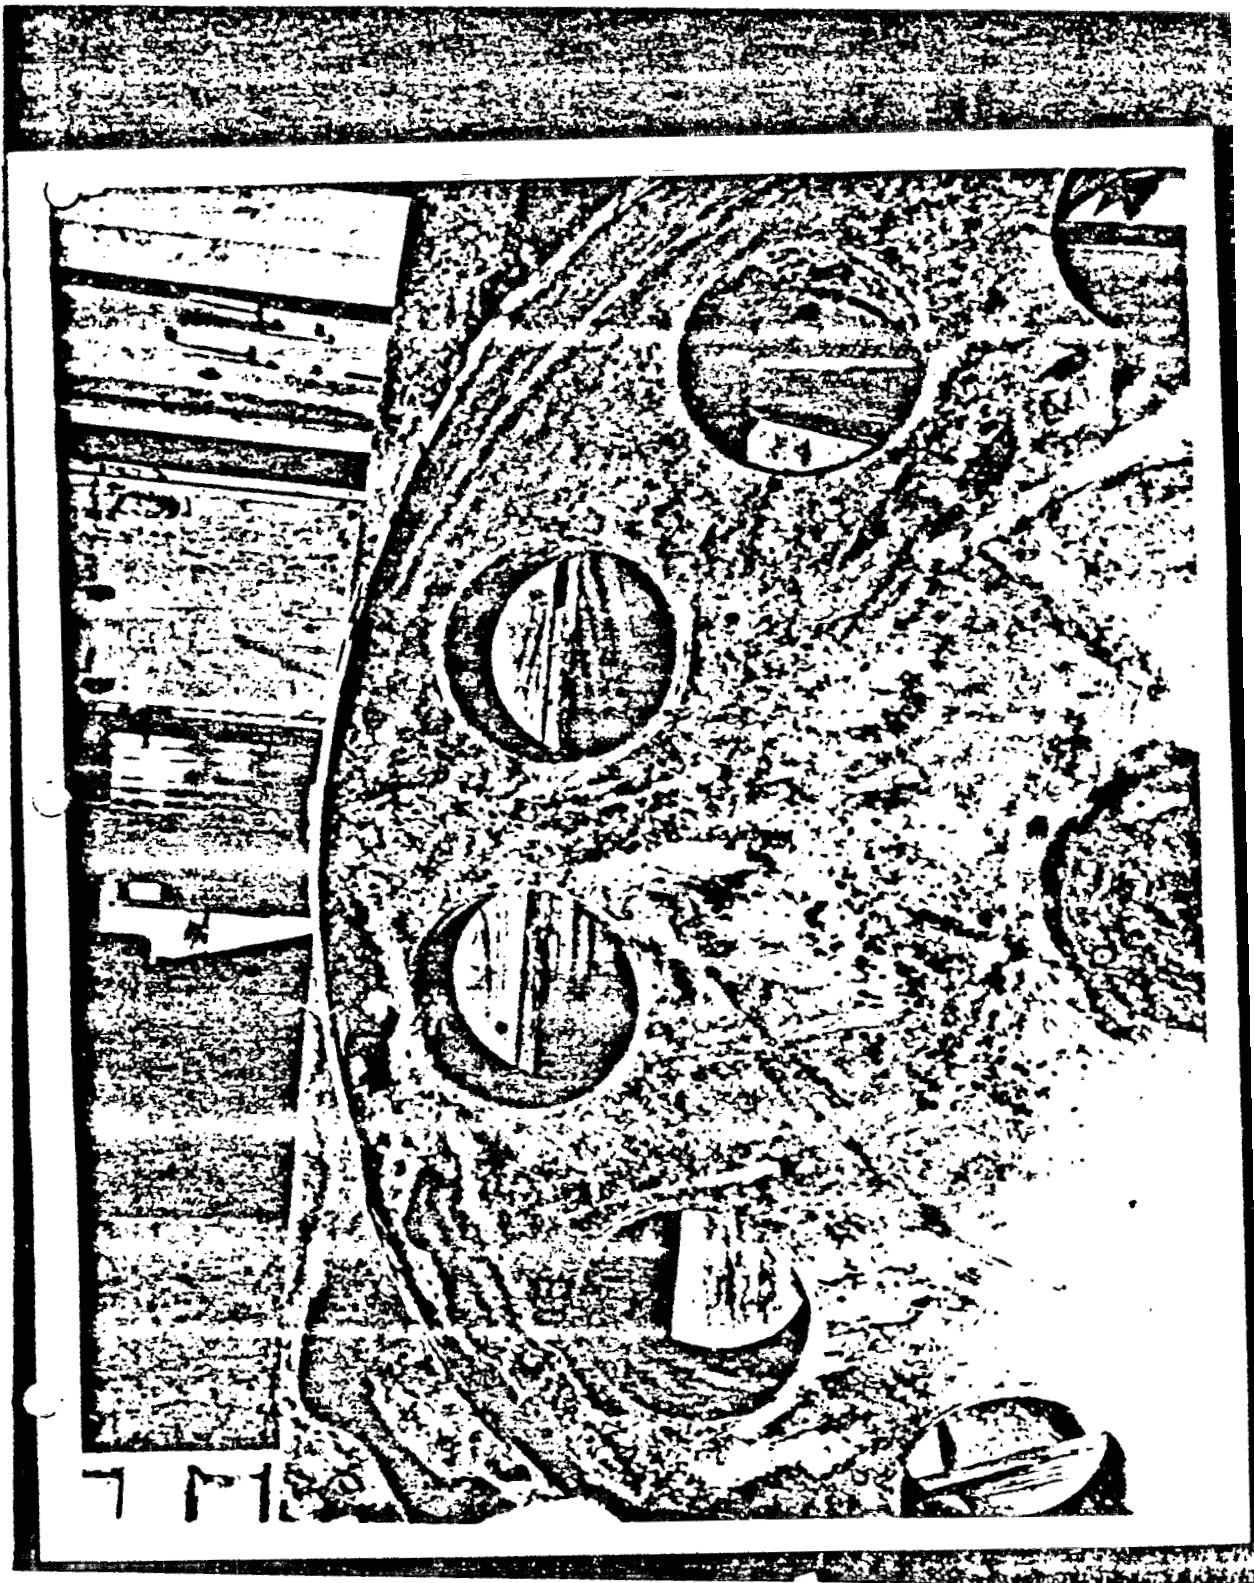
Lower Dial Assembly. Collection containers sit in the holes of the assembly.

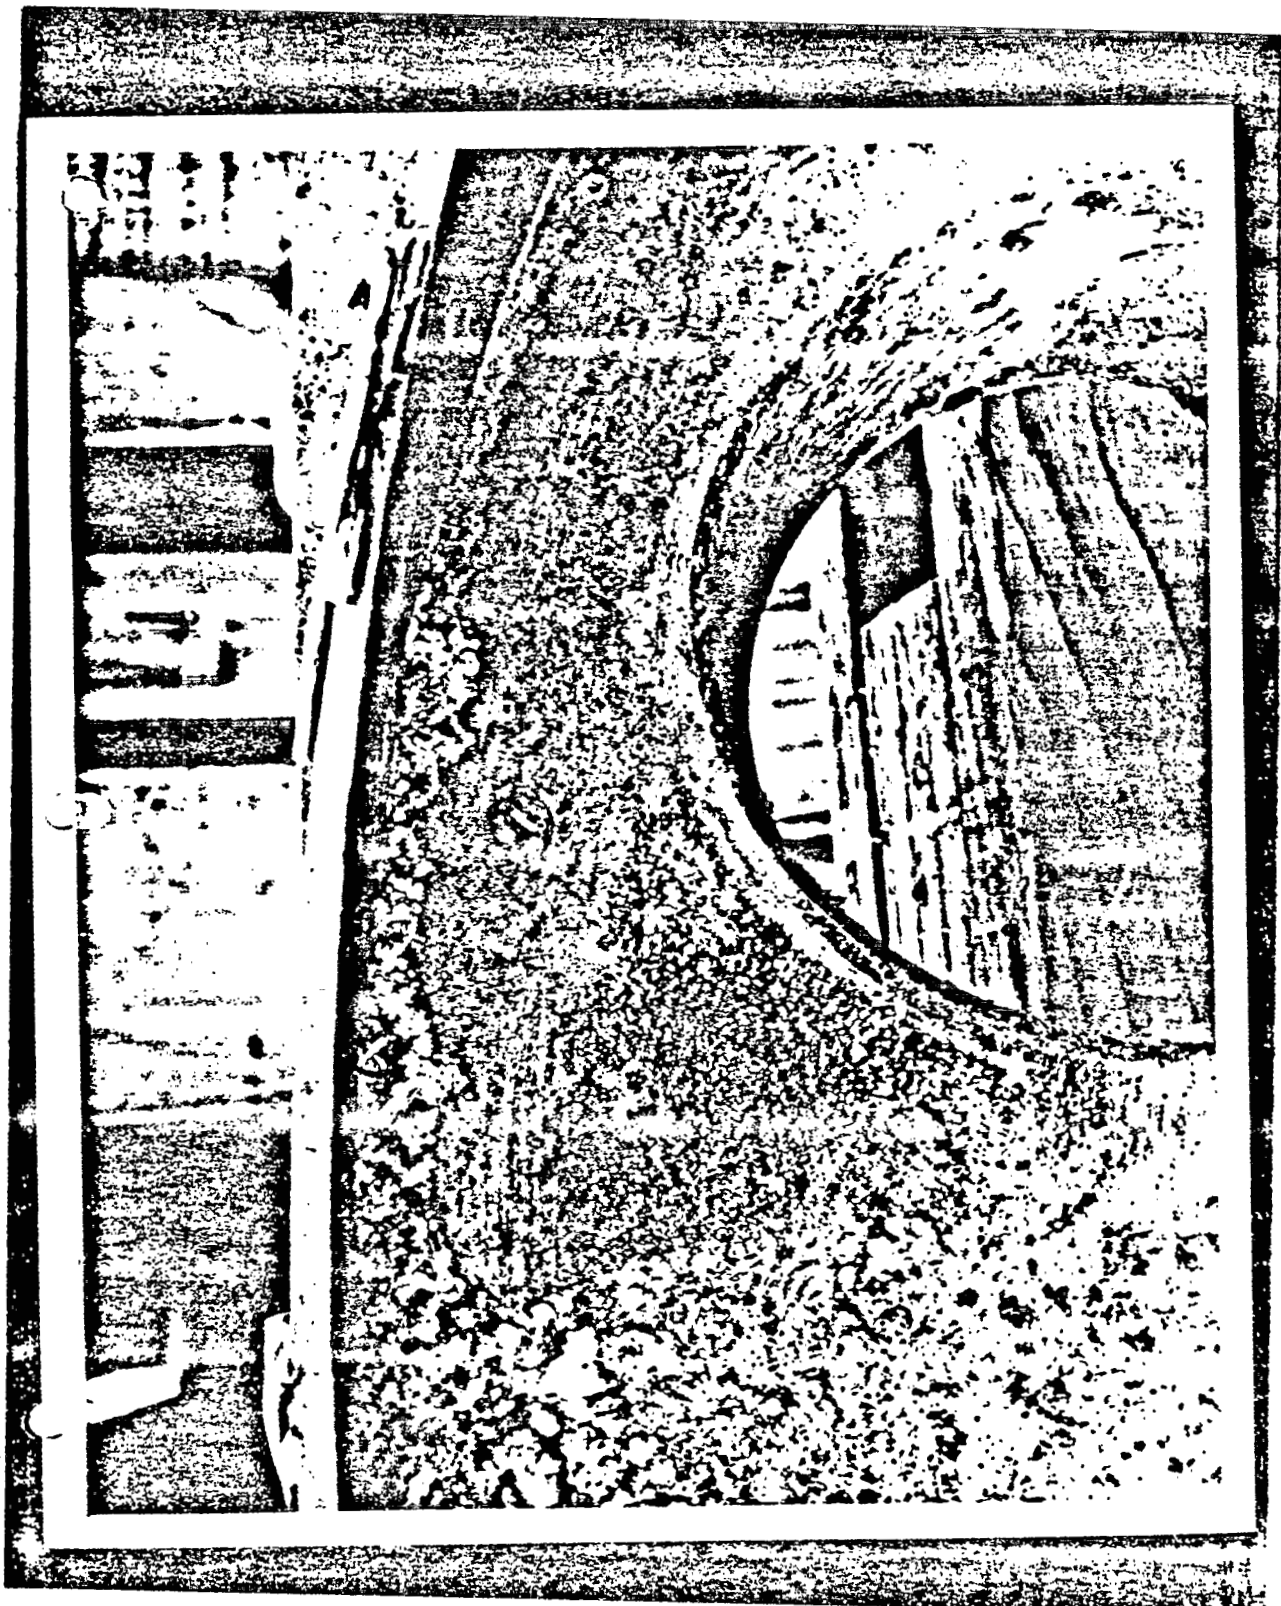
b. There was a buildup of material found between the wiper and the dial table. This material was nonconductive. The age of the material was not known. A pitted area discovered on the dial table near the 1 o'clock position. There was a corresponding mark as well as uneven wear on the dial wiper. There was also a good signature of a reaction at this location. This would indicate a probable point of initiation.

a. The most probable cause of initiation is electrostatic charge discharging between the wiper arm, collection can, and draw-off table.

b. A secondary cause of initiation is friction and heat due to varied clearances, and foreign matter buildup on the lower surfaces of the wiper blades.

Lower dial assembly near possible point of ignition.

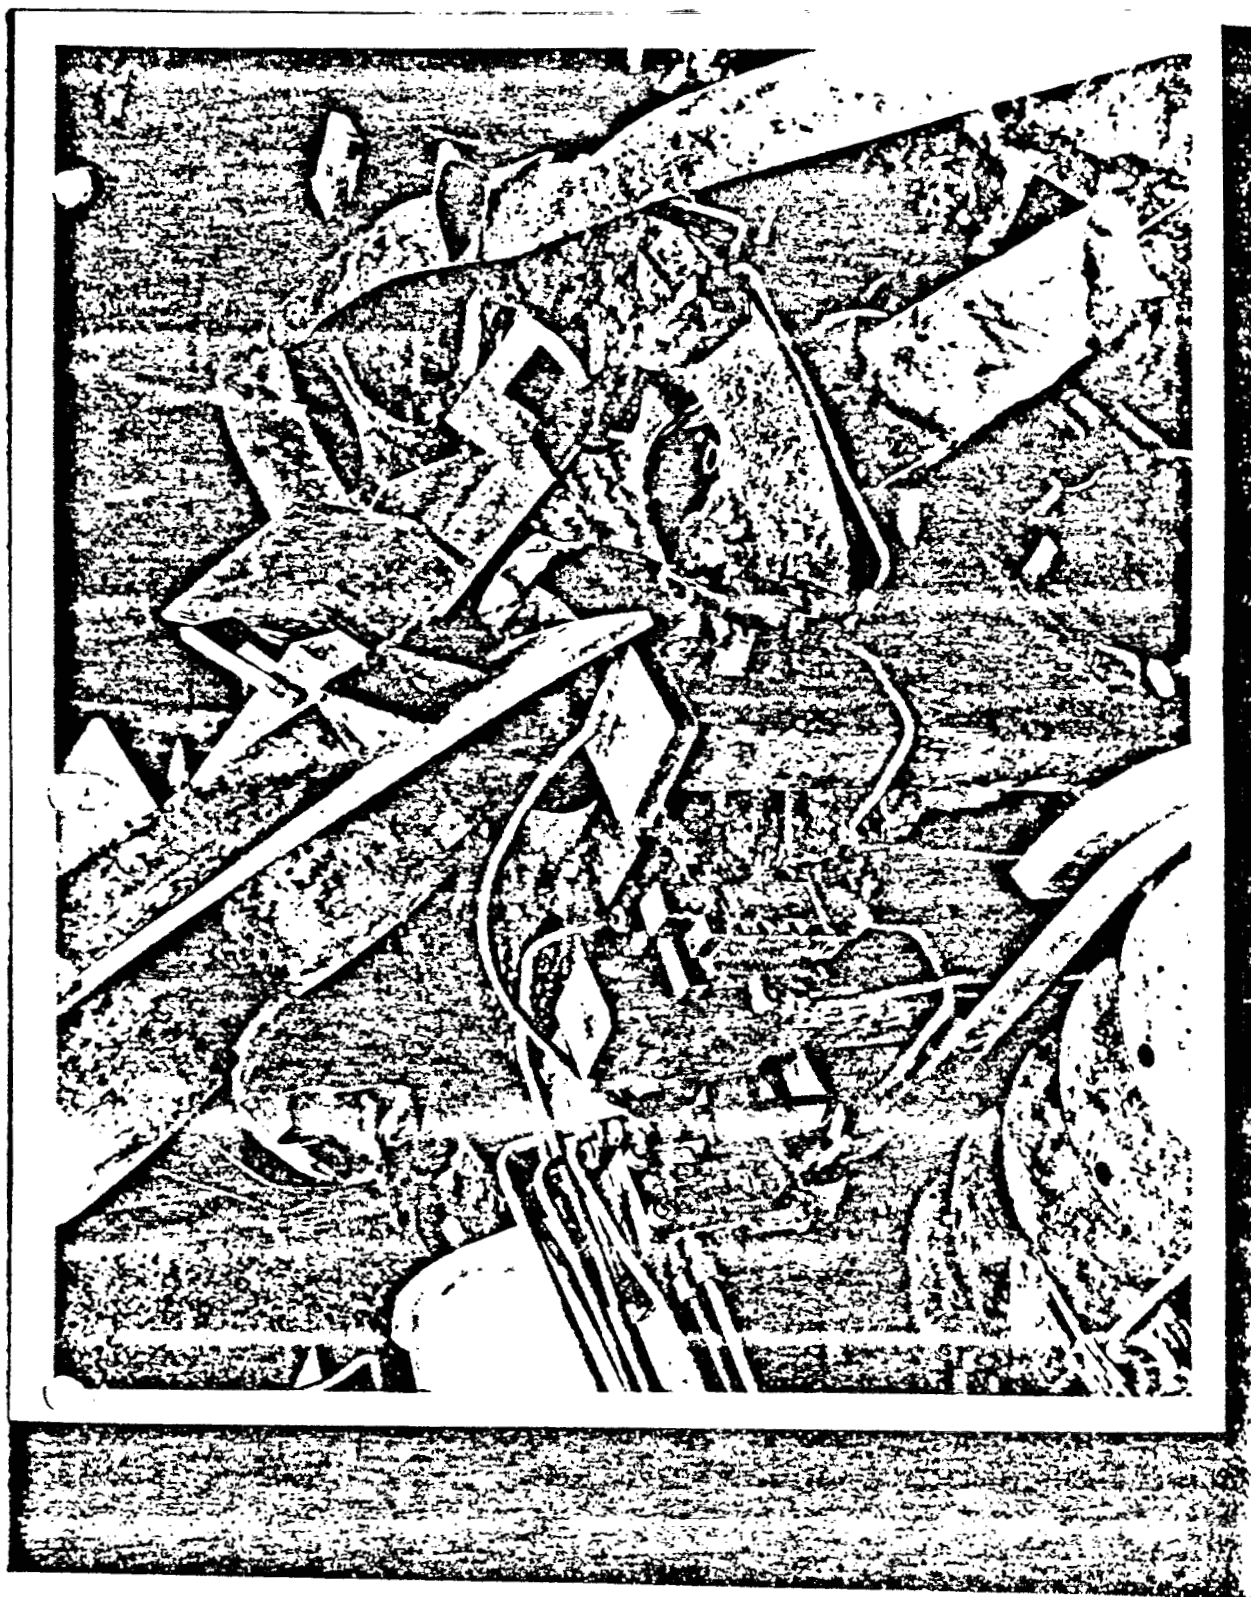
Lower assembly after the explosion is in the center of the picture.
